A fresh approach to monitoring wagon wheel health

Flats on wagon wheelsets continue to pose a derailment risk to railways around the world. Technology company Trilogical believes its novel approach to monitoring vibration could offer more reliable insights into wheelset condition.

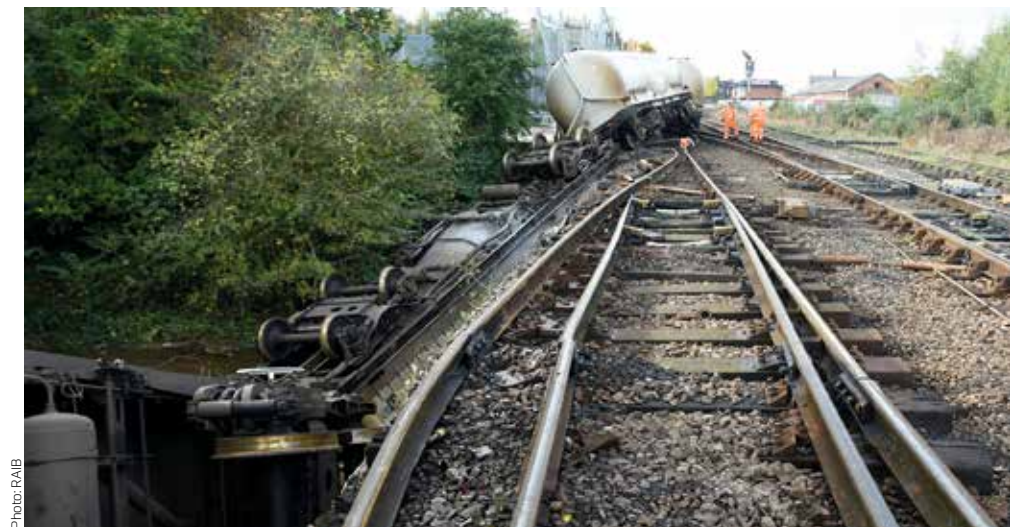
Photo: RAIB

The scene of the freight train derailment near Carlisle, northwest England, in October 2022.

Just over two years later, in October 2022, a severe wheel flat on a cement wagon led to the derailment of five bogie tank cars at Petteril Bridge Junction near Carlisle. This wheel flat developed due to poor adhesion conditions, causing the wheel to stop rotating.

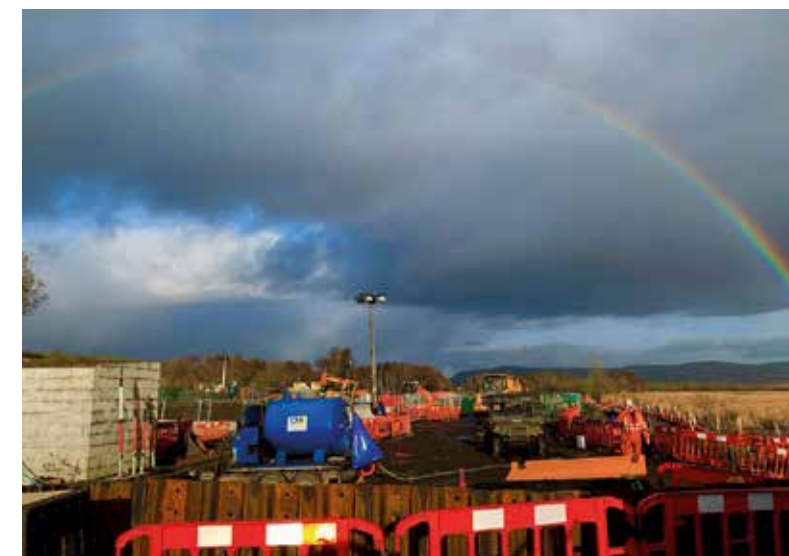
The oil train accident in south Wales in October 2020 led to considerable damage to a sensitive environmental site.

Examples of such incidents include a derailment in August 2020 of an oil train at Llangennech near Swansea in the UK. According to railway safety inspectorate RAIB, the derailment was caused by a wheel flat that developed after a brake malfunction led one axle to lock and slide for several kilometres. This meant that the wheels were unable to safely negotiate Morlais Junction, near Llangennech, damaging the pointwork and causing the third wagon to become derailed. The following wagons derailed on the damaged track.

Some of the derailed tank wagons were ruptured in the accident, and the spilling fuel ignited. A 230 mm wheel flat was

subsequently identified on the affected wagon wheelset, which had developed as a result of defective brake components. The losses and environmental damage caused by the oil spill and fire in an area of protected natural habitat were estimated at US\$75m.
